On the Relation Between Operating Conditions and Changes in Vibration Signature: A Case Study in Paper Mill

Basim Al-Najjar
Inst. for Industrial Engineering, Lund University,
Box 118, S-221 00 Lund, Sweden
Inst. for Mathematics, Statistic and Computer Science, Växjö University,
351 95 Växjö, Sweden
e-mail:Basim.Al-Najjar@masda.hv.se

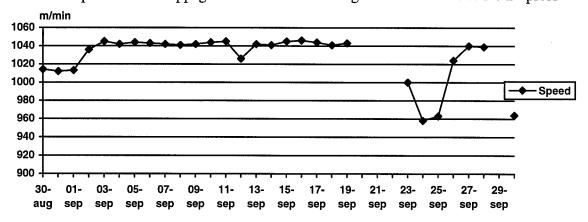
Fig. 1. The variation of the machine speed at the third and fourth drying cylinder groups, PM1. The discontinuity in the curve is due to lack of data at some days.

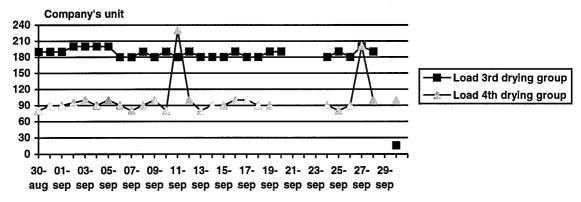
Fig. 2. Variations of the machine load at the 3rd and 4th drying cylinder groups, PM1. The discontinuity in the curve is due to lack of data at some days.

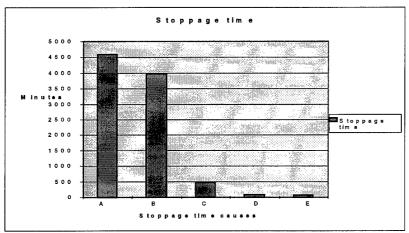
Fig. 3. Total stoppage time, (A), stoppage time due to unknown reasons, (B), stoppage time due to miscellaneous, (C), stoppage time due to shift in the tambour, (D), stoppage time due to slime, (E).

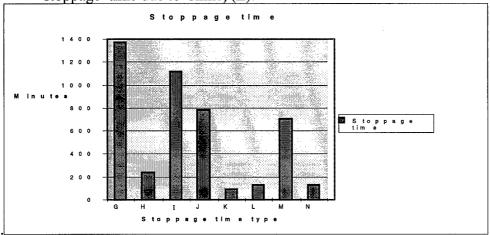
cylinder group, 3rd press cylinder group, 1st drying cylinder group, 2nd drying cylinder group, 3rd drying cylinder group, 4th drying cylinder group, calender and pope, see Fig. 4. The plot shown in Fig. 4 displays that the stoppage times accumulated due to failures in the 3rd press cylinder group, 1st and 2nd drying cylinder groups and Calender are; 1370, 1120, 786 and

Fig. 4. Stoppage time due to; failures in the 3rd cylinder group, (G), failures in the 3rd press cylinder group, (H), failures in the 1st drying cylinder group, (I), failures in the 2rd drying cylinder group, (K), failures in the 4th drying cylinder group, (L), failures in calender, (M), failures in pope, (N).

709 minutes, respectively. The number of stoppages experienced by PM1 during this period was about 490 stoppages. It is obvious that there exist distinguishable differences between the machine speeds measured by the operator and that recorded by the vibration technician, see Tables 1, 2 and 3. The minimum differences, about 0 and + 0.02 revolution per second, (rps), were experienced in 941013 and 941222, respectively, and the maximum differences, about 0.85 and 0.75 rps, were in 940901 and 941208, respectively.

Results and Discussions: The plot of the stoppage time accumulated due to failures in the machine parts specified, see Fig. 4, reveals that the problem areas ranked according to their economic importance are the 2nd press cylinder group, 1st and 2nd drying cylinder groups and Calender. The problem areas distinguished by this study contradict those which were identified based on the personnel experience. Machine rotational speed and loading were not constant during operation, and they varied partly stochastically and partly according to production plans. The result of data analysis presented in Tables 1, 2 and 3 reveal appreciable changes in the vibration amplitudes of the frequencies specified when the machine speed and load were changed at the different operating conditions. The machine speed was always recorded by the vibration technician at the times when vibration measurements were done in addition to the record kept by the operator which includes one or two measurements of the speed daily. In most cases, the machine speeds recorded by the vibration technician and operator were made at different times of the day. This may cause some uncertainty in the differences of the speeds recorded by these two persons.

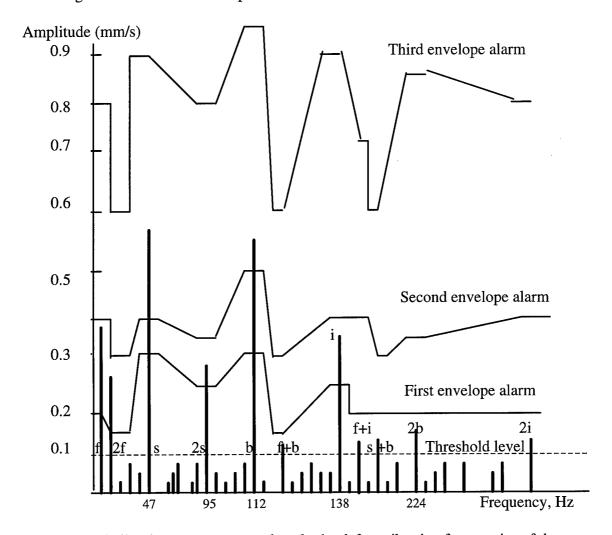
Example: The data used in this example are not all real but they are reasonable and based on the author's practical experience within paper mill industry. Assume that we have n nominally identical rolling element bearings installed at the driven sides of n drying cylinders, in a paper mill machine. In such a case the bearings can be considered to be exposed to approximately the same operating conditions, such as load, speed and temperature. Let the vibration frequencies which can be used to detect and follow damage developments in these bearings at an early stage be; 1*BPFO, 2*BPFO, 1*BPFI, 2*BPFI, 1*SBF, 2*SBF, 1*FTF, 2*FTF, (1*FTF+1*BPFO), (1*FTF+BPFI) and (1*SBF+1*BPFO) [2]. Also, let the three alarm levels, i.e. defect initiation, development and replacement, of each of these frequencies be; (0.3, 0.5, 0.95), (0.2, 0.35, 0.85), (0.25, 0.4, 0.9), (0.2, 0.4, (0.8), (0.3, 0.4, 0.9), (0.25, 0.35, 0.8), (0.2, 0.4, 0.8), (0.15, 0.3, 0.6), (0.15, 0.3, 0.6), (0.2, 0.4, 0.8), (0.15, 0.3, 0.6), (0.15, 0.3, 0.6), (0.2, 0.4, 0.8), (0.15, 0.3, 0.6), (0.15, 0.3, 0.6), (0.2, 0.4, 0.8), (0.2, 0.8, 0.8), (0.2,0.4, 0.7) and (0.2, 0.3, 0.6), respectively, measured in mm/s. These levels can be estimated from the VBM database for the machine when enough identical bearing replacements have been recorded [2,7,8]. Make the alarm level at each frequency cover a range equal to 1.5% at either side of the designated frequency to compensate for the variations in the bearing defect frequencies. It is possible then to set the three-level envelope alarm for the above frequencies, manually or through the software. For easiness, let the location of each of the chosen vibration frequencies in the envelope alarm shift to the right or left precisely the same amount of increment or reduction in the planned running speed, respectively. Also, let the alarm levels increase or decrease by double the amount of increment or reduction in the planned load, respectively. Now, assume that at time $t_1 > t_1$, the vibration and operating conditions are measured once more simultaneously, and it is found that the vibration spectrum is not appreciably changed, but the running speed and load are increased by 10% each. This means that all bearing defect frequencies are shifted by about 10% to the right of their original positions and their amplitudes are increased by at least 20%. In this case, using a three-level dynamic envelope alarm, which should be adjusted manually (or automatically), no warnings would be expected even if operating conditions are changed appreciably, see Fig. 5.

However, this is not possible if the envelope alarm is not adjusted, which is the case in general when using commercial VBM programs including one or, sometimes, two-level envelope alarms. Thus, the replacement of the bearing is indicated even though it is still functioning. For example, frequency b=112.1 Hz, which has 0.5 mm/s amplitude, will shift to the right by about 11 Hz and its amplitude may increase to 0.6. This means that frequency b will shift to the range which is very close to that occupied previously by the frequency (f+b)= 117 ± 2 Hz. In other words, frequency b would exceed the third envelope alarm level and lead to unnecessary bearing replacement, when the real amplitude of frequency b remained at only 52% of the replacement level 0.95 mm/s, see Fig. 5. In general, using a three-level envelope alarm, whether dynamic or not, for bearing defect frequencies increases the bearing's useful life, because the bearing is usually replaced as soon as its vibration level exceeds the normal, i.e. when it is still below the second alarm level [8]. A dynamic three-level envelope alarm would increase the bearing useful life appreciably and reduce the number of planned and unplanned replacements because the ambiguities, which arise due to changes in speed and load, and cause inaccuracy in the assessment of the bearing condition, will be eliminated. In many cases, setting and adjusting envelope alarms manually is very difficult and expensive especially when it concerns thousands of measurement points. Now, if these three envelope alarms are normalised to one RPS and produced in a software program, which is automatically

Fig. 5. A typical vibration spectrum reveals only the defect vibration frequencies of the bearing 23052 cck/SKF and the three assumed envelope alarm levels, where b, 2b, i, 2i, s, 2s, f, 2f, (f+b), (f+i) and (s+b) are 1*BPF0, 2*BPF0, 1*BPFI, 2*BPFI, 1*SBF, 2*SBF, 1*FTF, 2*FTF, (1*FTF+1*BPF0), (1*FTF+BPFI) and (1*SBF+1*BPF0), respectively. The speed is assumed to be 10 rps. For the bearing 23052 cck/SKF, FTF=0.45 Hz, SBF=4.73 Hz, BPFO=11.21 Hz and BPFI=13.79 Hz, all normalised to 1 rps. All the frequencies below the threshold level are considered insignificant.

adjustable depending on operating conditions, then envelope alarm setting and adjusting for all n bearings will be easier and cheaper.
